# *Land Subsidence at Atchuweli, Jaffna; A Case Study from Sri Lanka*

**National Building Research Organisation**

# *Atchuweli, Jaffna*

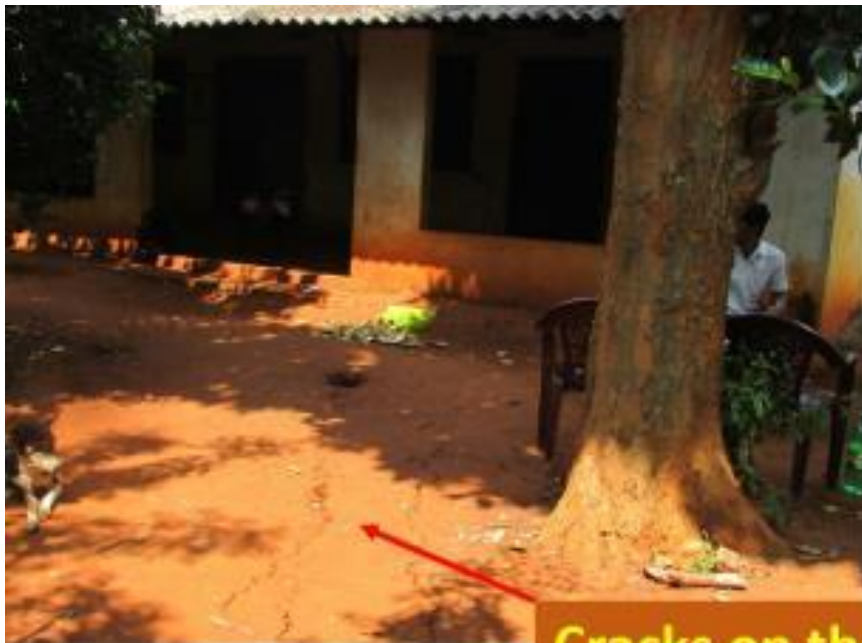
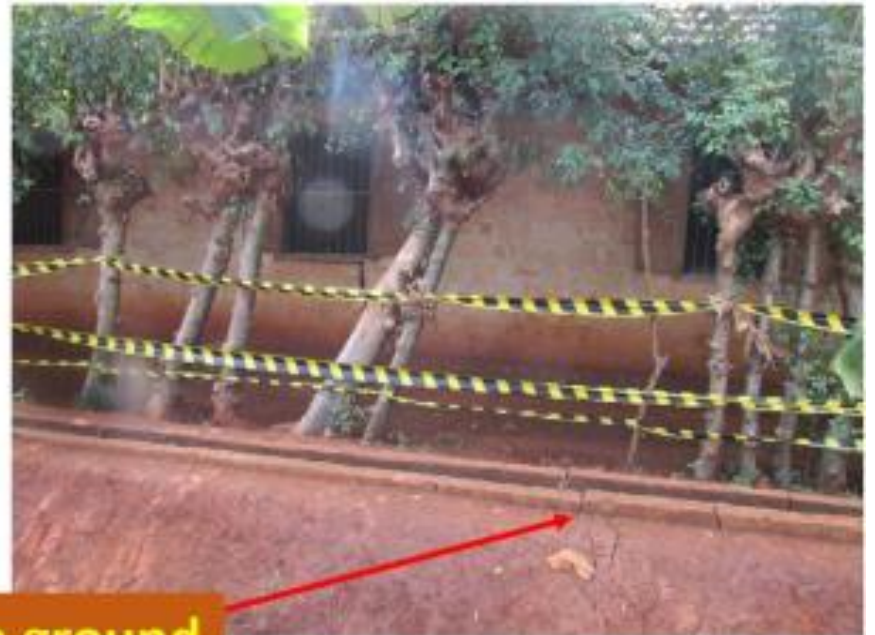
Cracks on the ground

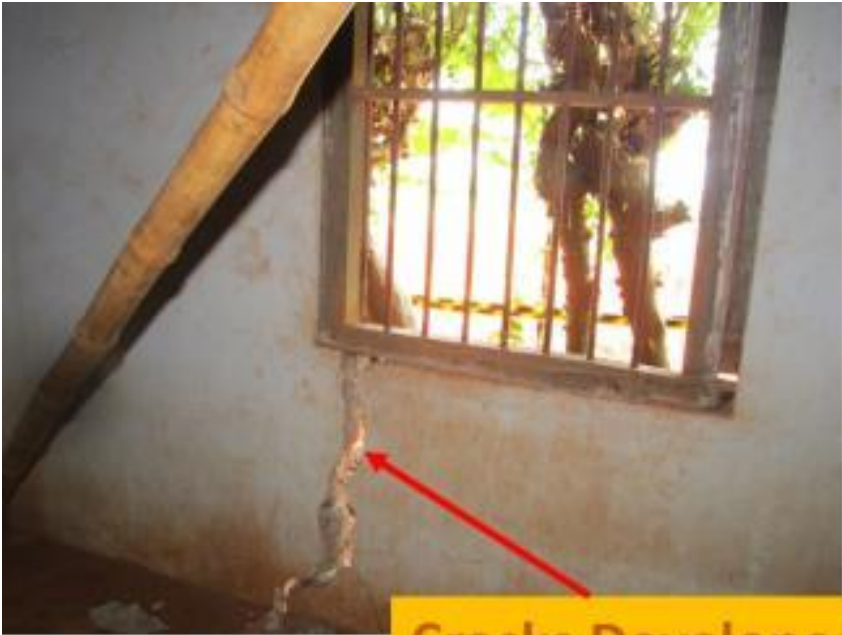
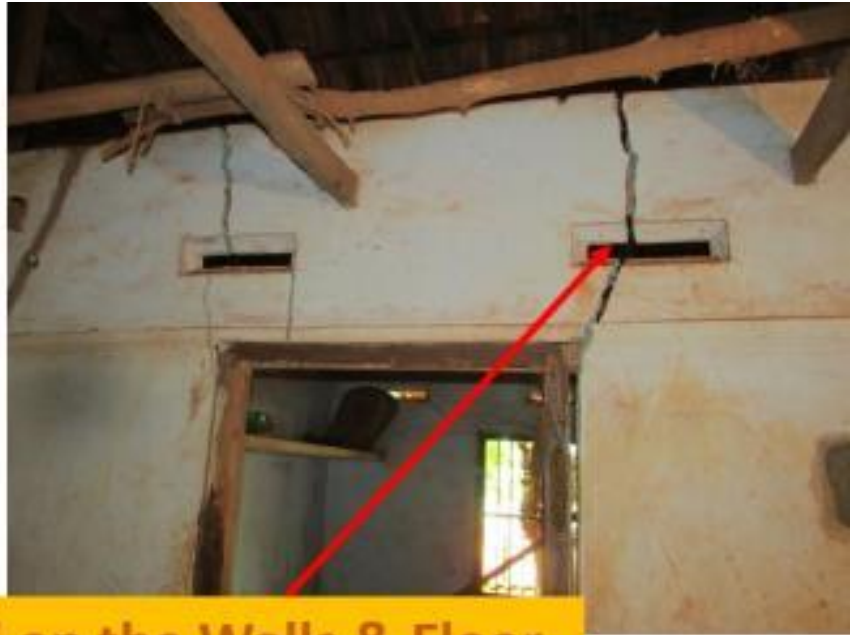
**Cracks Developed on the Walls & Floor**

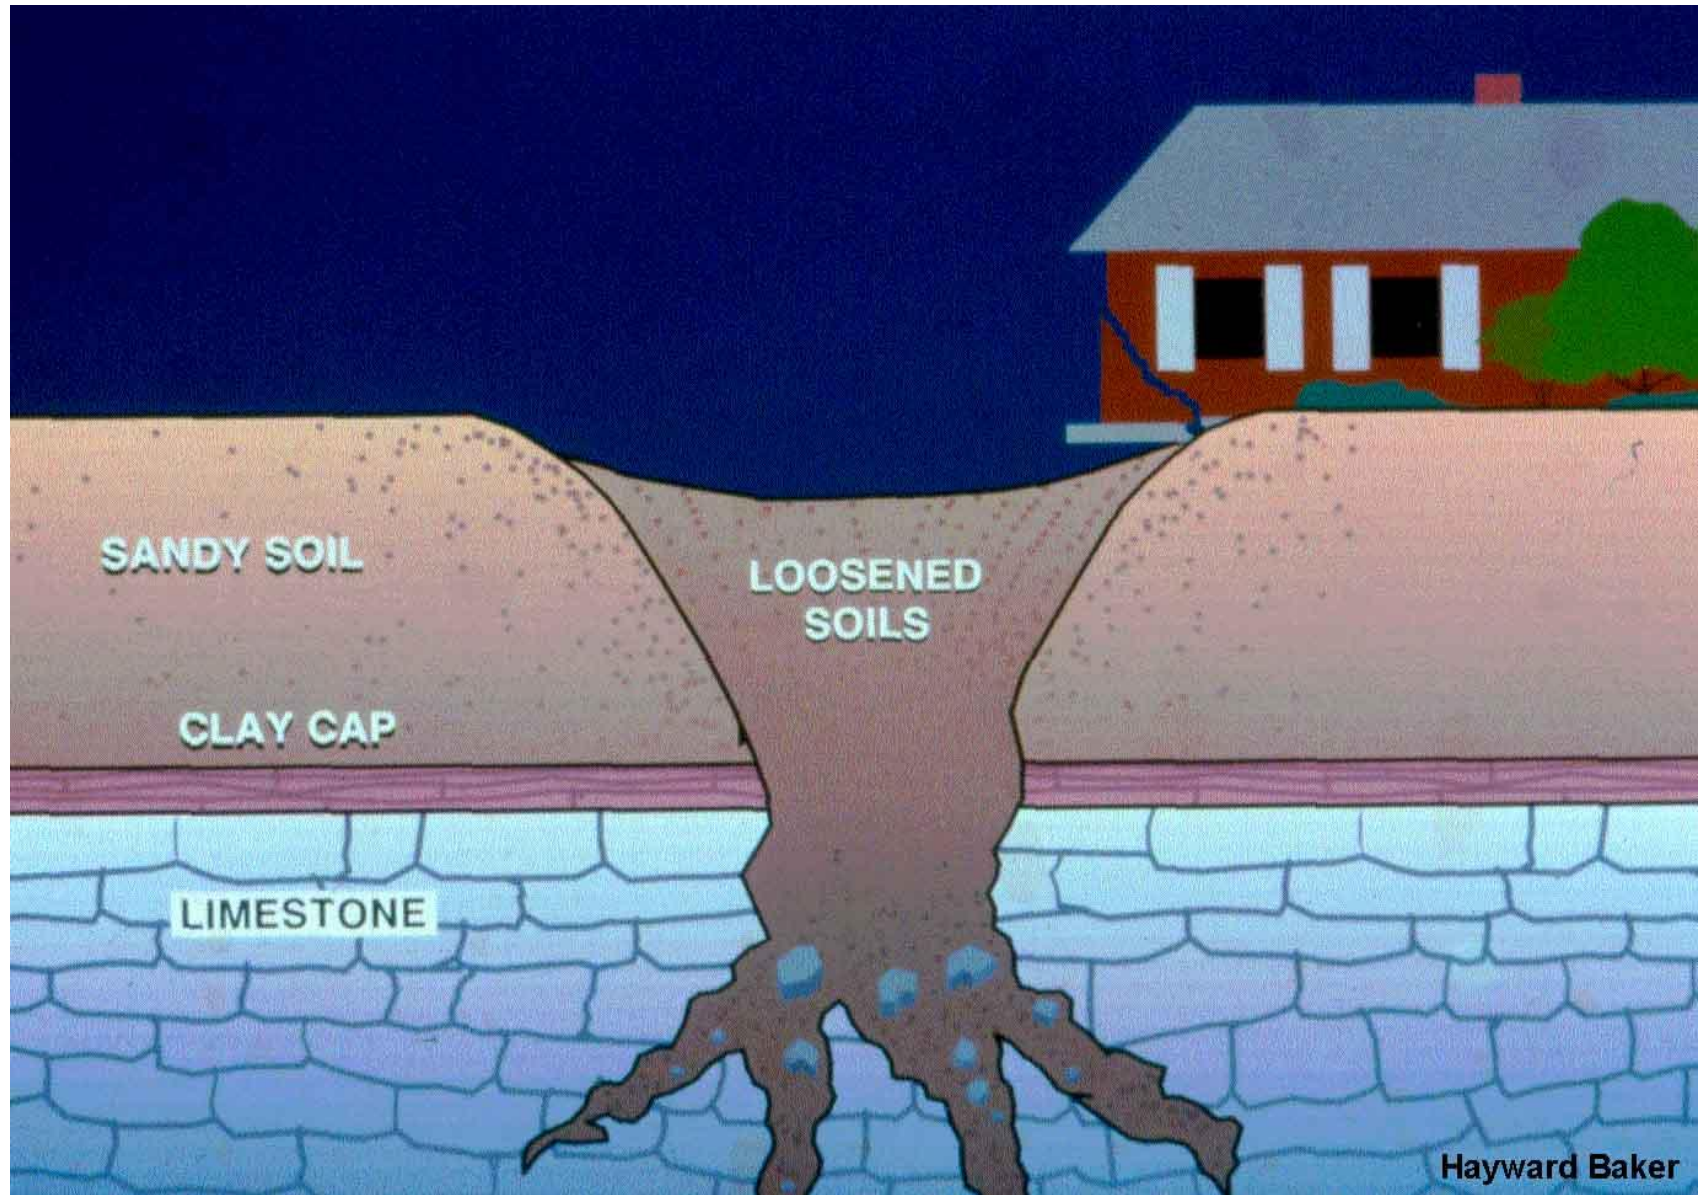
SANDY SOIL

CLAY CAP

LIMESTONE

LOOSENED  
SOILS

- It seems mainly due to dissolution of carbonate parts of the limestone*

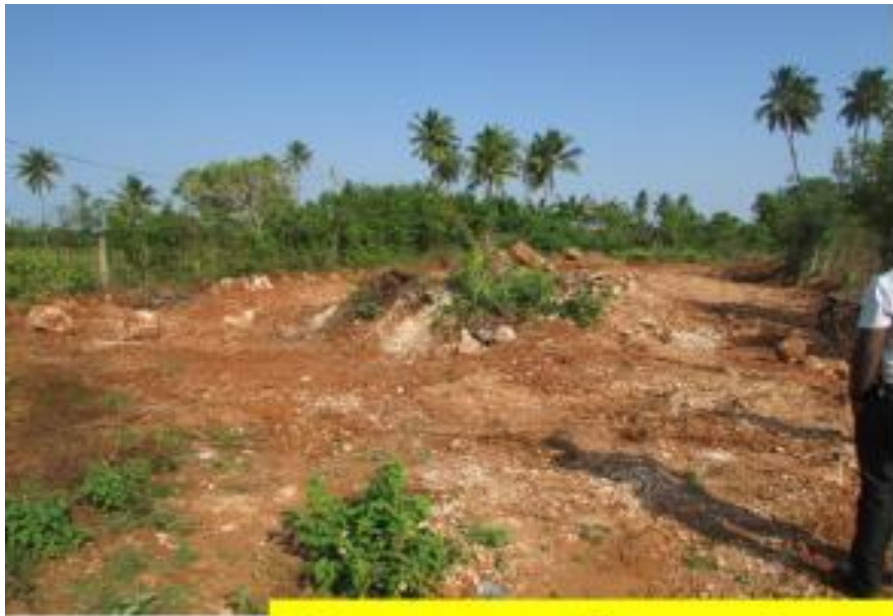
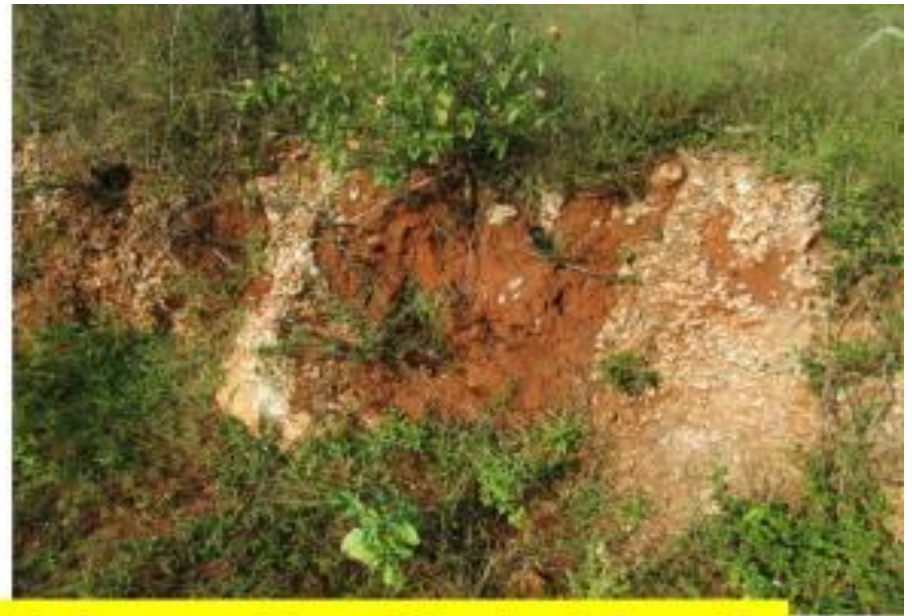
**Limestone formation and the cavities filled with soil**
