Nuwan Kumarasinghe
Senior Electronics Engineer
Department of Meteorology

Automatic Data Acquisition Systems used in Sri Lanka towards Disaster Risk Reduction

International Workshop on 'Mitigation of Disasters due to Severe Climate Events: From Policy to Practice' Colombo, Sri Lanka, 10-13 March 2016

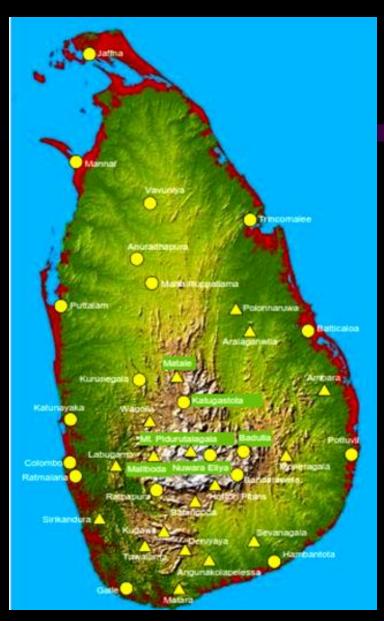
AWS Network in Sri Lanka 20 Principal 18 Co

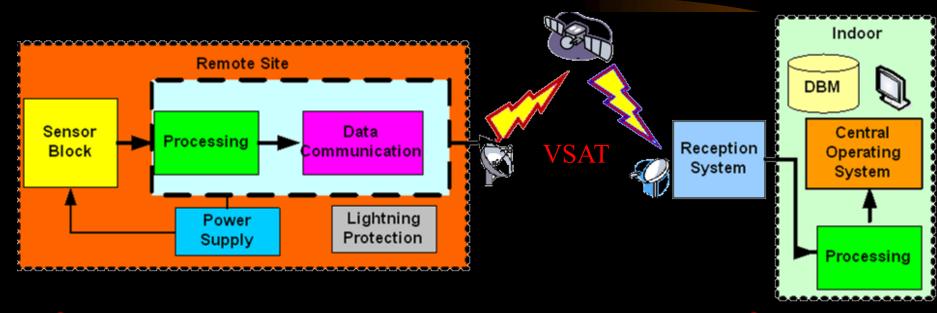
AWS System

- Sensors
- Solar Power
- Data Base

- Processing
- Lightning Protection
- COS

- VSAT
- Receiver
- Display

Sensors are the Heart of the System

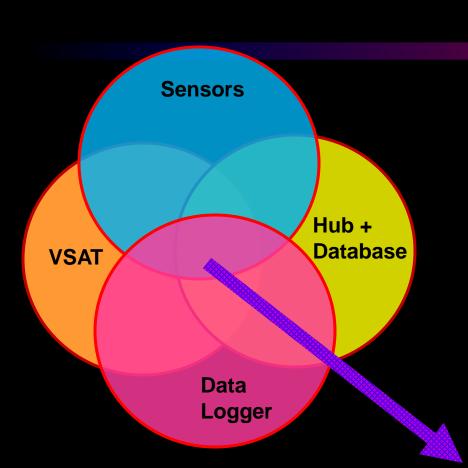
Successful Operation of AWS Network

Performance of Sensors,
Data Logger, VSAT, Hub
and Data Base was
verified. 10 Minute Data x
144 x 365x 6 years =
315,360 Data

"Successful Operation" is obtained when all these sub systems are in perfect operation.

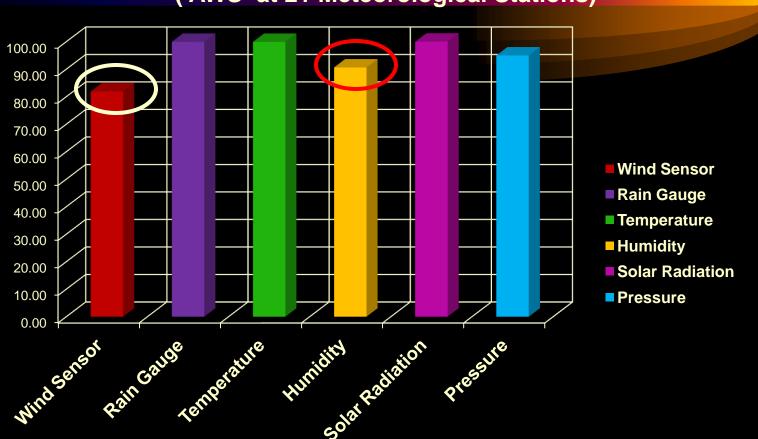
Successful
Operation of
AWS Network

AWS at 21 Meteorological Stations

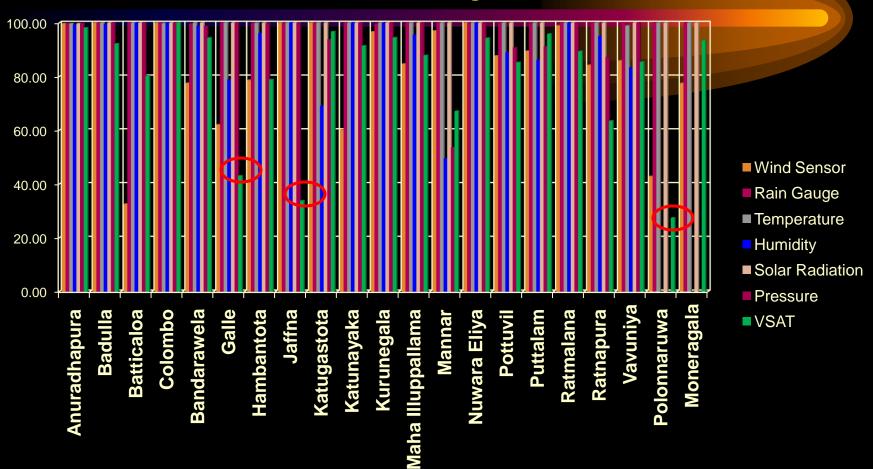
Performance of AWS

(2009-2015) AWS at 21 Meteorological Stations
