PHYSICAL AND SOCIAL ENVIRONMENTAL ASSESSMENT OF DODANDENIYA AND WATAGODA LANDSLIDES IN MATALE

Presented by : W.D.G.D.T.Rajapaksha

National Building Research Organization

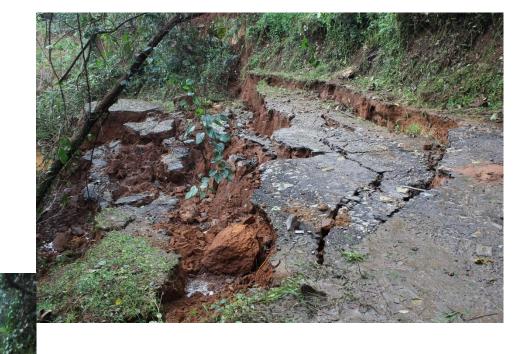
Landslide at Watagoda

CROWN

TOE

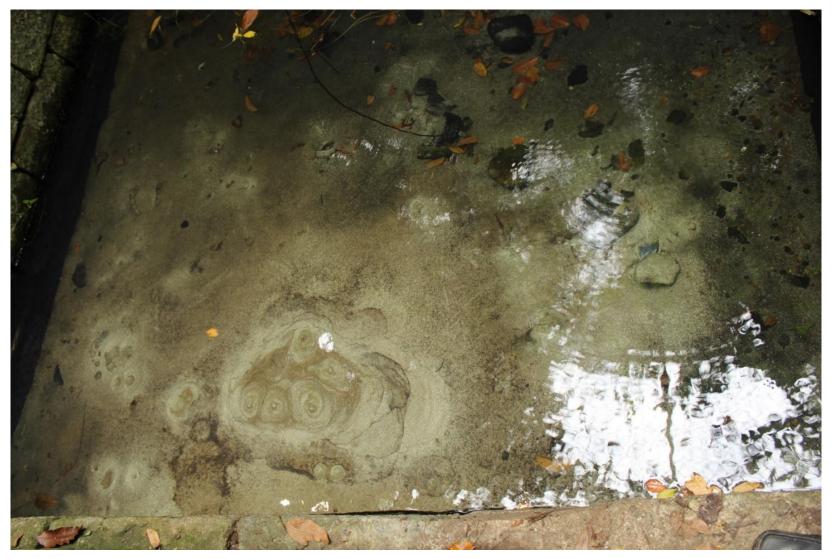
Spring with extreme rate of flow close to the suspected cavity region
